## Preserving the Sistine Chapel Is a Never-Ending Task. See Stunning Behind-the-Scenes Photos of What It Takes

"Preventative conservation" is the key to keeping the ceiling looking fresh.

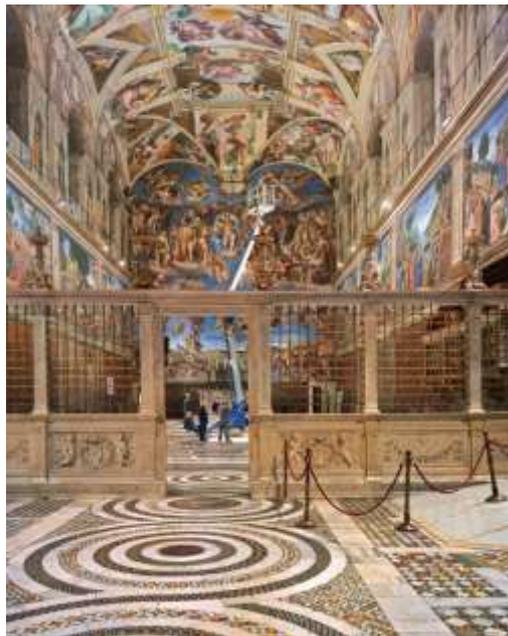
The Spider (the Multitel SMX 250) and the Sistine Chapel. Photo by Robert Polidori for *WSJ Magazine*.

But despite the Vatican's best efforts, thin layers of contamination inevitably develop. Carbon dioxide reacts to the plaster of the frescos. Through the process of condensation and evaporation, bacteria accumulates. The result is an almost imperceptible whitish glaze of soluble salts above the surface of the painting. To prevent the work from being damaged, staff clean the frescos regularly and remove contaminants while they are still soluble, using a crane-like machine nicknamed the Spider—a Multitel SMX 250 self-propelled tracked platform—to access the high-up paintings.

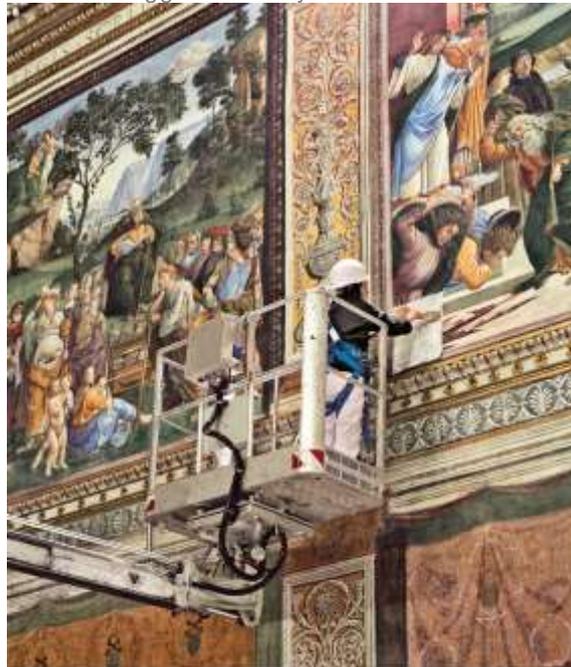
A master conservator demonstrating a technique for removing contaminants from a Botticelli fresco in the Sistine Chapel. Photo by Robert Polidori for *WSJ Magazine*.

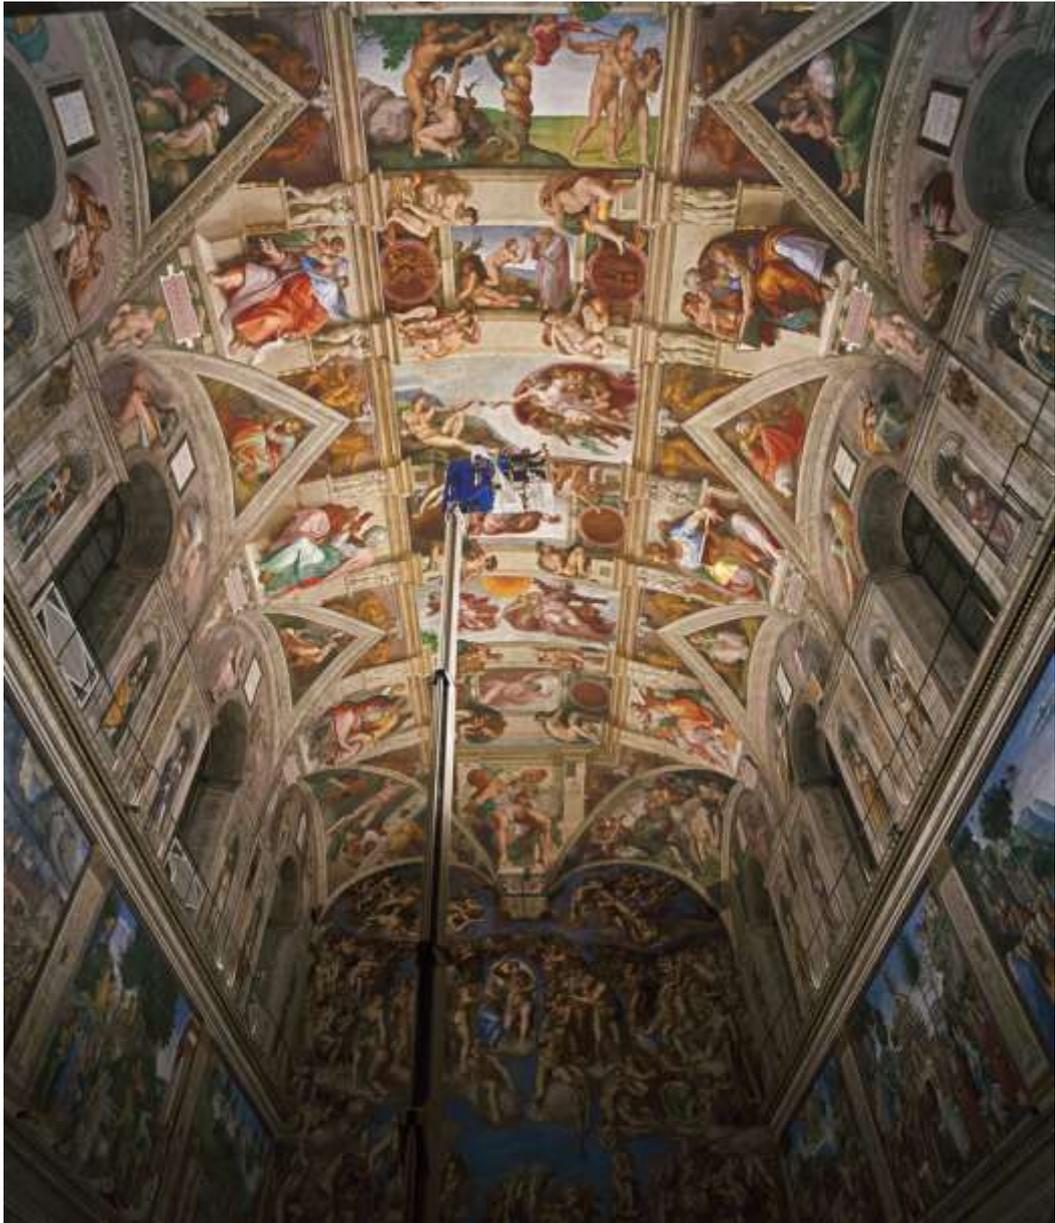
The Spider (the Multitel SMX 250) and the Sistine Chapel's ceiling. Photo by Robert Polidori for *WSJ Magazine*.
